Spair Imaging Roof Integrity Report

Property Address:	707 Ave T Lubbock, TX 79415 BLDG 1 - Report 3
Date of Inspection:	March 25, 2026
Condition Score:	95 / 100 — Critical
AI Urgency Assessment:	Our AI has identified severe deterioration and active risk. We recommend immediate action to protect your home.

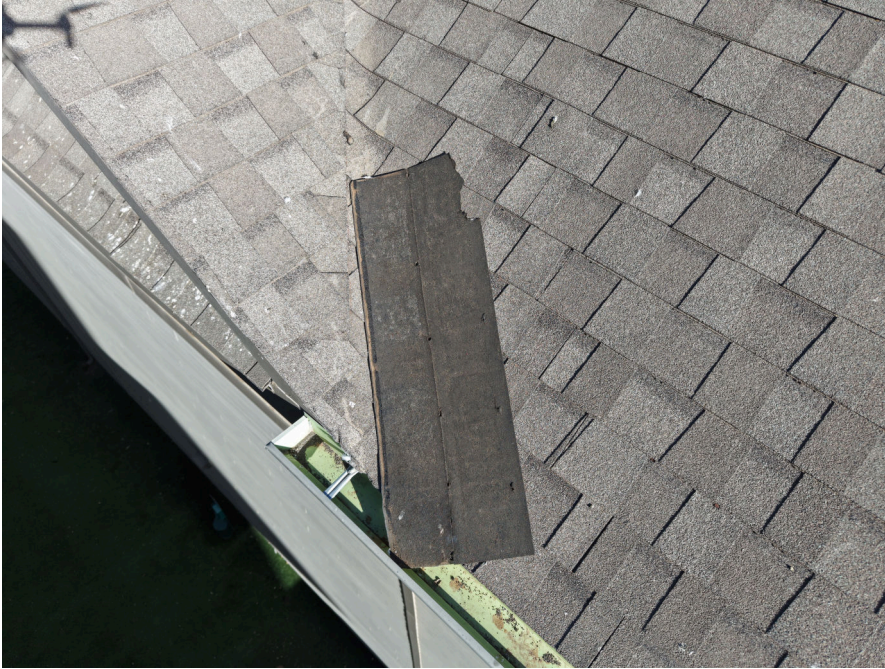
Mechanical Damage (100%)

Location: Center of the roof slope shown in the image.

A large, dark piece of roofing material, likely a shingle or section of underlayment, is lying loose on top of the installed shingles. It has a torn edge and visible nail holes, indicating it was detached from another location.

Hail Damage (90%)

Location: Scattered across the visible roof slope.

Multiple small, circular, dark spots are visible on the architectural shingles. These impacts are consistent with hail strikes that have bruised the shingle mat and displaced granules. At least 5-10 distinct impacts are visible in the photo.

Metal Denting (85%)

Location: Inside the gutter on the left side of the image.

The light green interior surface of the gutter shows multiple small, dark, circular marks consistent with dents from hail impacts. This serves as collateral evidence for a hail event.

Granule Loss (80%)

Location: Across the roof slope, particularly on the left side near the gutter.

There are patches of generalized granule loss, exposing the dark asphalt layer. This appears to be from general weathering and age, in addition to the specific points of hail impact.

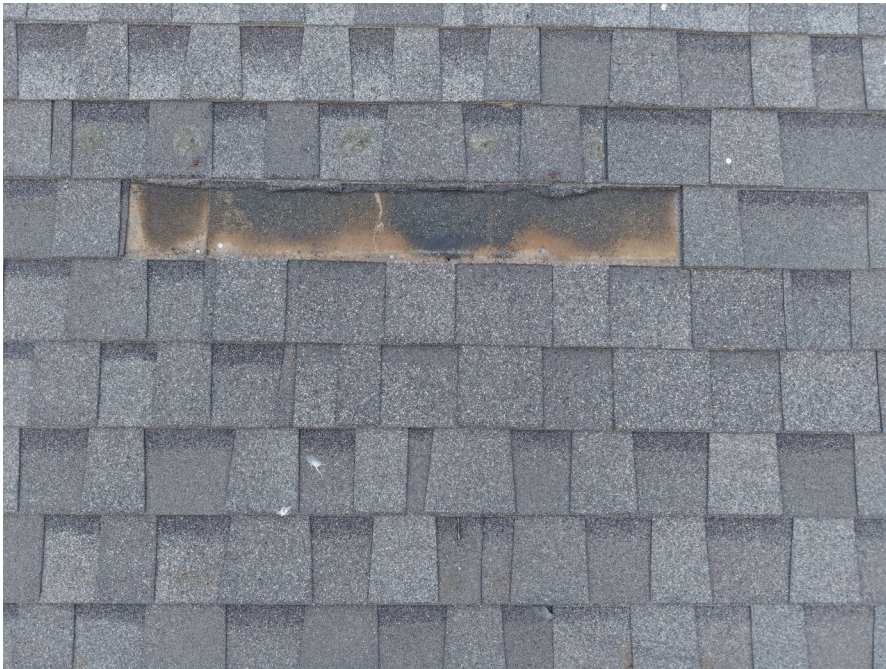
Missing Shingles (100%)

Location: Center of the image, third row from the top.

One complete architectural shingle tab is missing, exposing the underlying shingle layer and fasteners. This creates a direct path for water intrusion.

Hail Damage (90%)

Location: On the shingle course directly above the missing shingle.

At least two distinct circular impact marks (hail hits) are visible on the shingles above the missing one. These impacts show significant granule loss, exposing the dark asphalt matting.

Exposed Nails (100%)

Location: In the area of the missing shingle and on the shingle course above it.

Multiple exposed nail heads are visible. Two are located in the exposed area where the shingle is missing, and one rusty nail is driven through the face of the shingle above. These are potential leak points.

Granule Loss (95%)

Significant granule loss is present in circular patterns consistent with hail impacts, compromising the protective surface of the shingles.

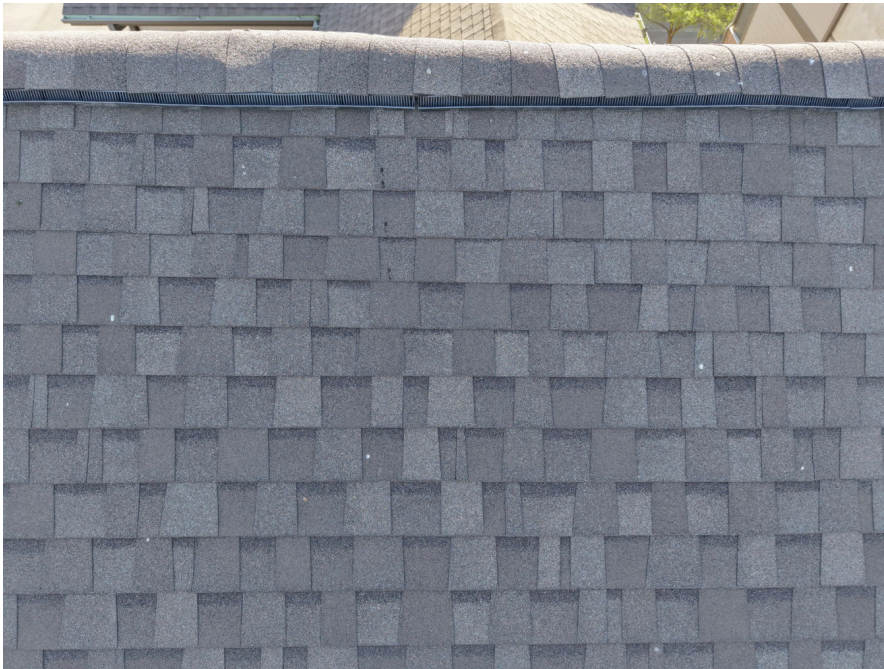
Hail Damage (90%)

Location: Scattered across the entire visible roof slope, including the field shingles and the ridge cap shingles.

Multiple small, circular impacts are visible across the roof surface. These appear as light-colored spots where granules have been knocked off, exposing the underlying mat. The damage is present on both the main slope and the ridge cap.

Wind Damage (85%)

Location: Ridge cap, towards the right side of the image.

One ridge cap shingle is visibly lifted and misaligned from the rest of the ridge line, indicating potential wind uplift or a fastener issue.

Cracked Shingles (70%)

Location: Center of the roof slope, approximately 4-5 rows down from the ridge.

At least one shingle exhibits a vertical thermal crack. The crack is fine and appears to be an isolated instance.

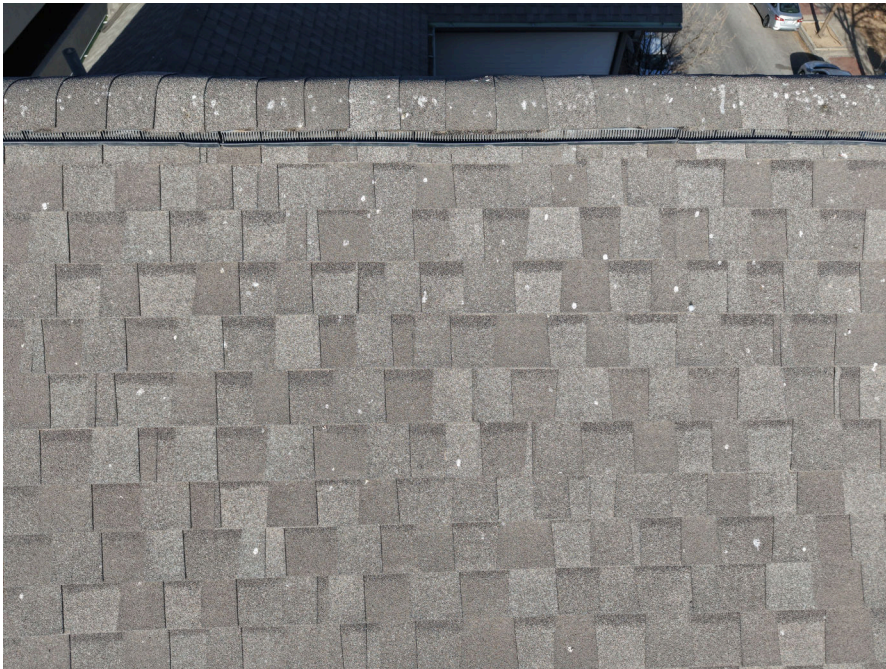
Hail Damage (100%)

Location: Widespread across all visible roof slopes and ridge cap shingles.

Numerous circular hail impact marks are visible across the entire roof surface, including the field shingles and ridge cap shingles. These impacts, appearing as light-colored spots, have resulted in significant granule loss, exposing the underlying shingle mat. The impacts are randomly scattered and consistent in nature, indicating a significant hail event.

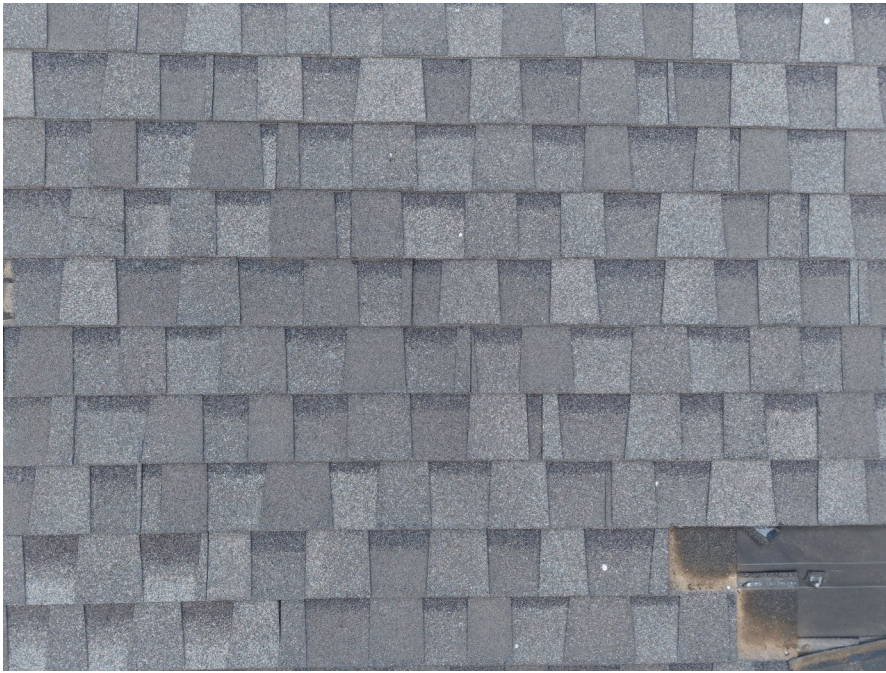
Missing Shingles (100%)

Location: Lower right corner of the image

Several shingle tabs are completely missing in the lower right section of the roof, exposing the underlayment and fasteners. The damage appears to be around a roof penetration or ridge cap.

Exposed Nails (100%)

Location: Lower right corner, in the area with missing shingles

Multiple exposed nail heads are visible where the shingles are missing. This is a significant water intrusion risk.

Hail Damage (85%)

Location: Scattered across the visible roof surface

Multiple small, circular spots of granule loss consistent with hail impacts are visible across the roof. They appear as small white or light-colored dots on the shingle surfaces.

Mechanical Damage (90%)

Location: Lower right corner of the roof

The area with missing shingles shows signs of improper installation or a failed repair, with poorly cut shingles and exposed fasteners, indicating mechanical damage or poor workmanship.

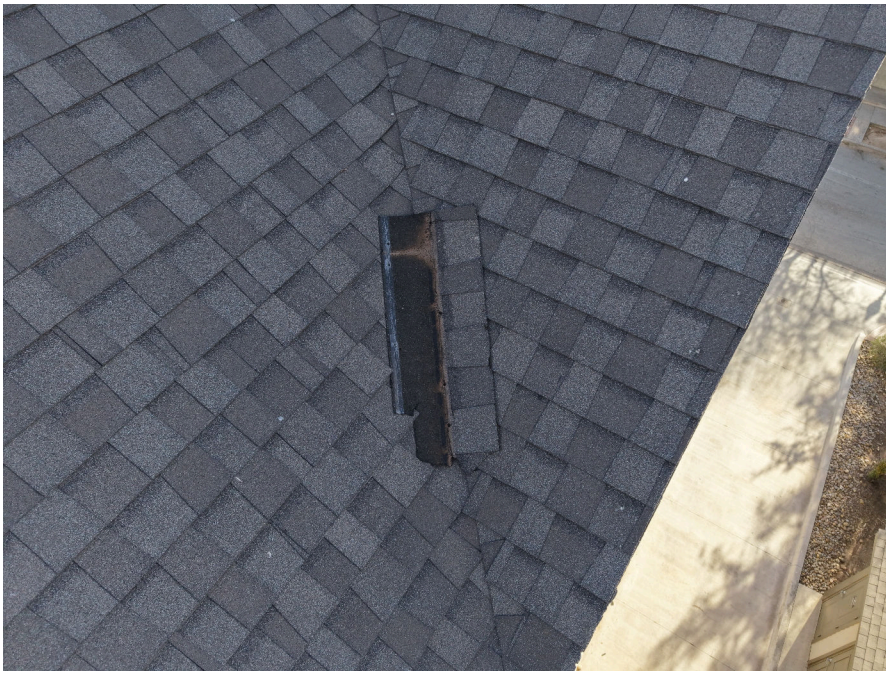
Flashing Damage (100%)

Location: Center of the roof slope, at a rectangular vent.

A rectangular box vent is severely damaged, with its cover missing or broken, exposing the flashing and underlayment. The flashing appears deteriorated and improperly sealed, creating a significant and active leak risk.

Shingle Damage (100%)

Location: Adjacent to the damaged central vent.

A shingle at the bottom right corner of the damaged vent is torn and lifted, compromising the shedding of water around the penetration.

Hail Damage (85%)

Location: Scattered across the visible shingles on both roof facets.

Numerous small, circular impact marks consistent with hail are visible on the shingle surfaces. These impacts have caused granule loss, appearing as dark bruises on the shingles, which compromises their integrity.

Granule Loss (90%)

Location: Widespread across the entire visible roof surface.

Noticeable and widespread granule loss is evident on many shingles, indicated by lighter-colored, worn patches. This suggests the roof is aged and has reduced UV protection.

Exposed Nails (95%)

Location: On a shingle directly above the damaged central vent.

At least one exposed nail head is visible, creating a potential point for water intrusion. This may be due to improper installation or shingle movement.

Cracked Shingles (90%)

Location: On a shingle above and to the right of the central vent.

An isolated shingle exhibits a vertical crack, likely from stress or age, which can allow water to penetrate to the underlayment.

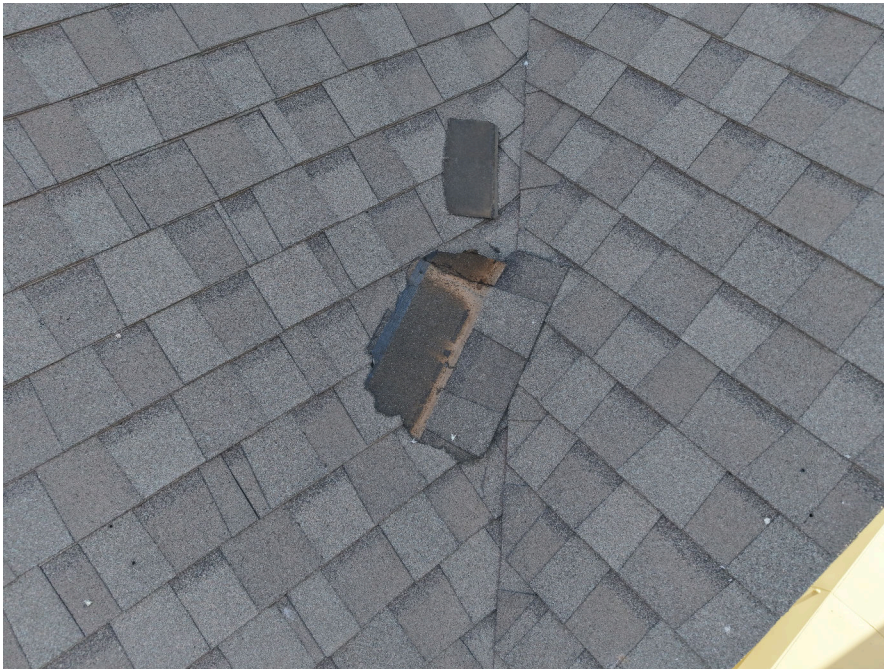
Wind Damage (100%)

Location: Center of the image, at the roof valley

A significant section of shingles, approximately 1-2 square feet, is torn off and missing, exposing the dark underlayment. The edges of the remaining shingles are jagged and ripped, indicative of wind uplift. A detached piece of shingle is resting on the roof surface nearby.

Missing Shingles (100%)

An area equivalent to 2-3 shingle tabs is completely missing, creating a direct path for water to the underlayment. This is an active failure point.

Hail Damage (90%)

Location: Scattered on the left and right roof planes

Multiple small, circular impact marks consistent with hail are visible. These appear as dark spots where granules have been forcibly removed from the shingle surface. At least 4-5 distinct impacts can be identified in the close-up views.

Granule Loss (95%)

Location: Widespread across both visible roof planes

There is noticeable and widespread granule loss on the upper edges of the shingle tabs, appearing as dark, weathered patches. This is a sign of age and environmental wear.

Cracked Shingles (90%)

Location: Adjacent to the area of missing shingles

Shingles surrounding the primary damage area show visible linear cracks, indicating they are brittle and compromised.

Exposed Nails (85%)

Location: Left roof plane, near the valley

At least one exposed nail head or sealant pop is visible as a white dot on the surface of a shingle, creating a potential point for water intrusion.

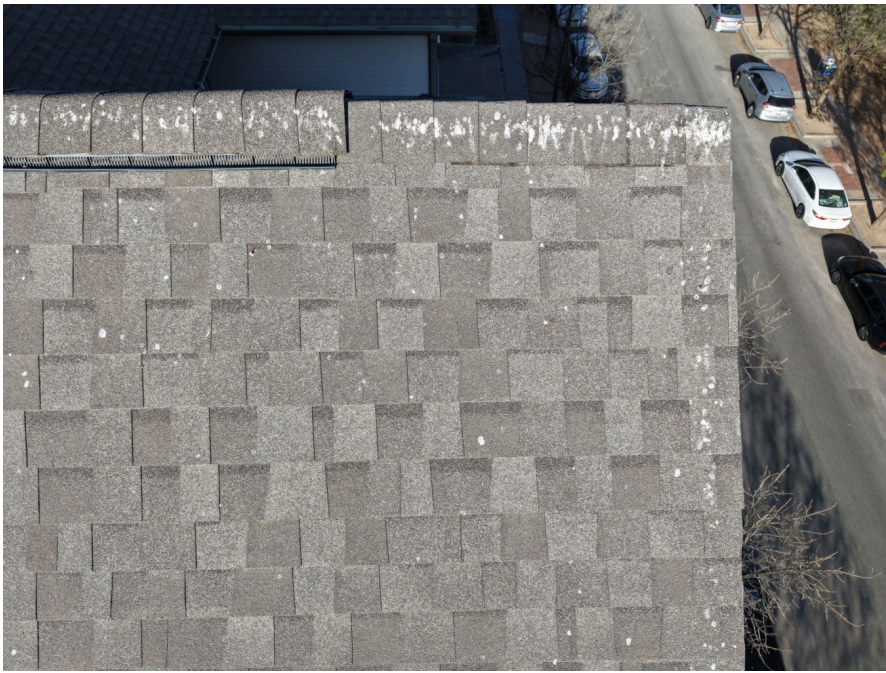
Hail Damage (90%)

Location: Scattered across the entire visible roof slope.

Numerous small, circular to slightly irregular light-colored spots are visible across the field shingles. These marks are consistent with hail impacts that have caused granule loss, exposing the underlying asphalt. Dozens of impacts can be seen in a random pattern.

Granule Loss (95%)

Location: Concentrated on the ridge cap shingles at the top of the image.

Severe and widespread loss of granules is present on the ridge cap shingles, appearing as large, irregular white and light-gray patches. This level of deterioration significantly compromises the protection of the ridge line.

Shingle Damage (95%)

Location: Widespread across the entire visible roof area, including field and ridge shingles.

The roof system shows widespread damage, combining numerous hail impacts on the field shingles with severe granule loss and deterioration on the ridge cap. This combination indicates a significant compromise of the shingles' integrity and protective function.

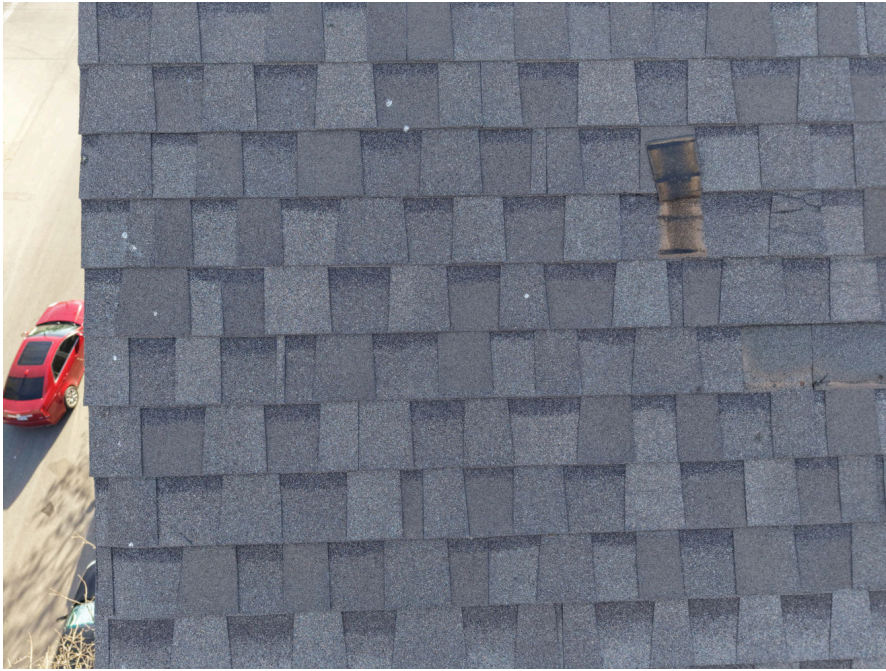
Hail Damage (90%)

Location: Scattered across the visible roof slope, with several concentrated on the left side.

Multiple small, circular impact marks are visible on the shingles, characterized by granule loss which creates lighter-colored spots. At least 5-7 distinct impacts can be seen in the provided images.

Mechanical Damage (80%)

Location: Upper right quadrant of the roof.

A piece of what appears to be a broken, dislodged vent cap or other debris is lying on the shingle surface. This can cause abrasion and further damage.

Cracked Shingles (95%)

Location: Upper right quadrant, near the debris on the roof.

A shingle has a clear horizontal crack. A shingle below this one also appears cracked with a lifted corner and granule loss.

Exposed Nails (90%)

Location: On a damaged shingle below the debris in the upper right quadrant.

At least two nail heads are visible on a cracked shingle. Exposed fasteners are a significant leak risk.

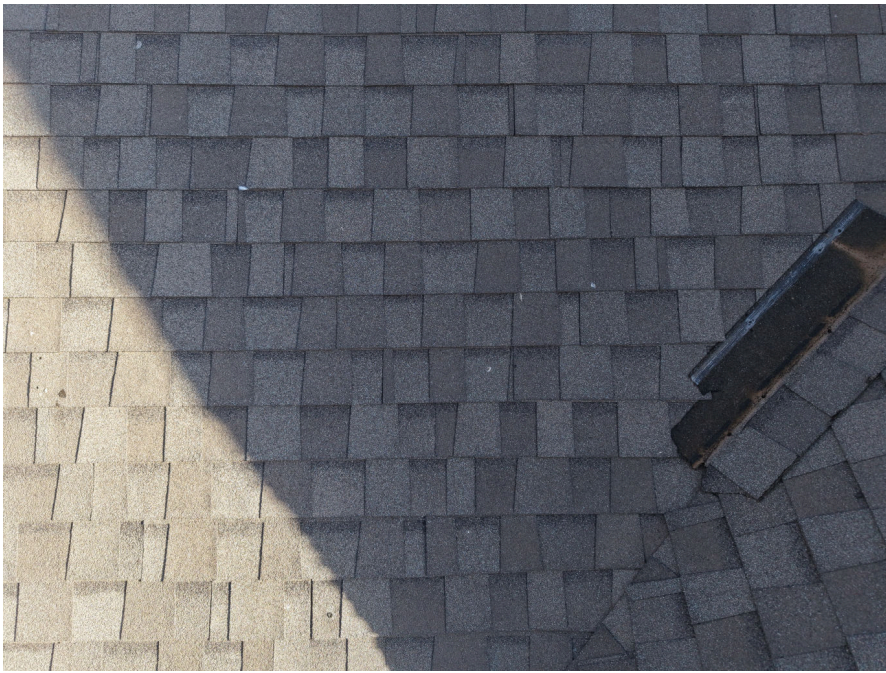
Hail Damage (90%)

Location: Scattered across the roof slope, visible in both sunlit and shaded areas.

Multiple small, circular impact marks consistent with hail are visible. These appear as dark divots where granules are pressed into the asphalt mat and lighter spots where granules have been knocked off. At least 3-4 distinct impacts can be identified.

Shingle Damage (100%)

Location: Hip/ridge cap on the right side of the image.

The end piece of the hip/ridge cap is severely deteriorated, torn, and lifted. The underlying material is exposed, indicating a failure of this component.

Exposed Nails (100%)

Location: Sunlit area on the left side of the image.

At least one exposed nail head (nail pop) is clearly visible on the face of a shingle, creating a potential water intrusion point.

Granule Loss (70%)

Location: General across the roof surface.

Minor and diffuse granule loss is visible across the shingles, consistent with age and wear, separate from the concentrated loss at hail impact points.

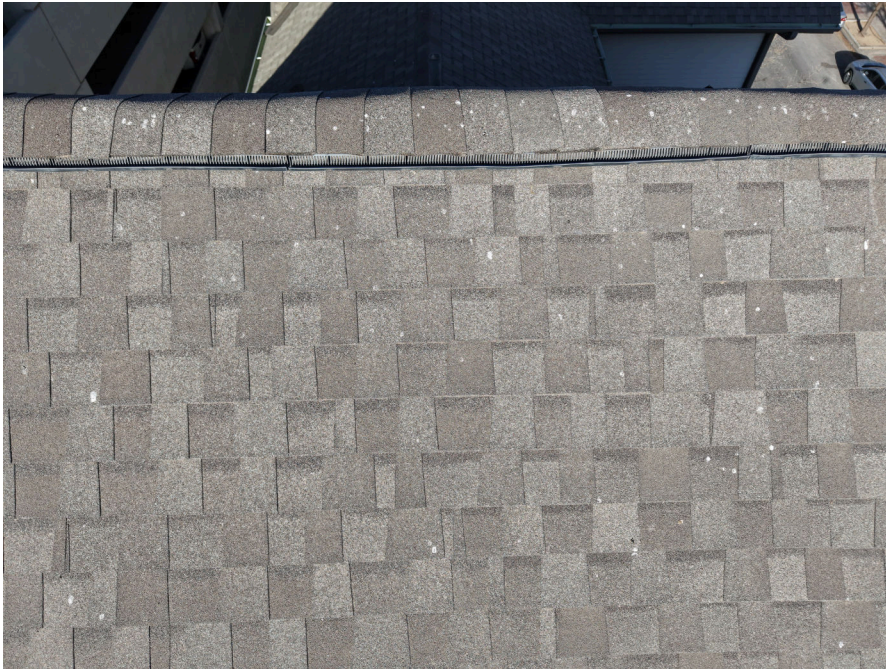
Hail Damage (50%)

Location: Scattered across the roof field

A few small, subtle, circular spots are visible, which could be interpreted as minor hail impacts where granules are displaced. The marks are not distinct or numerous, making the evidence for hail inconclusive.

Granule Loss (80%)

Location: Widespread across the shingle surfaces

Minor and diffuse granule loss is evident across the shingles, consistent with normal weathering and age. There are no large bald spots.

Algae Moss (90%)

Location: Scattered across the ridge cap and field shingles

Numerous white splotches, consistent in appearance with bird droppings, are visible on the roof surface. This is a cosmetic issue.

Exposed Nails (85%)

Location: On the ridge cap, to the left of the center break in the pest guard.

At least one fastener head appears to be exposed on the ridge cap, which can become a potential point of water intrusion.

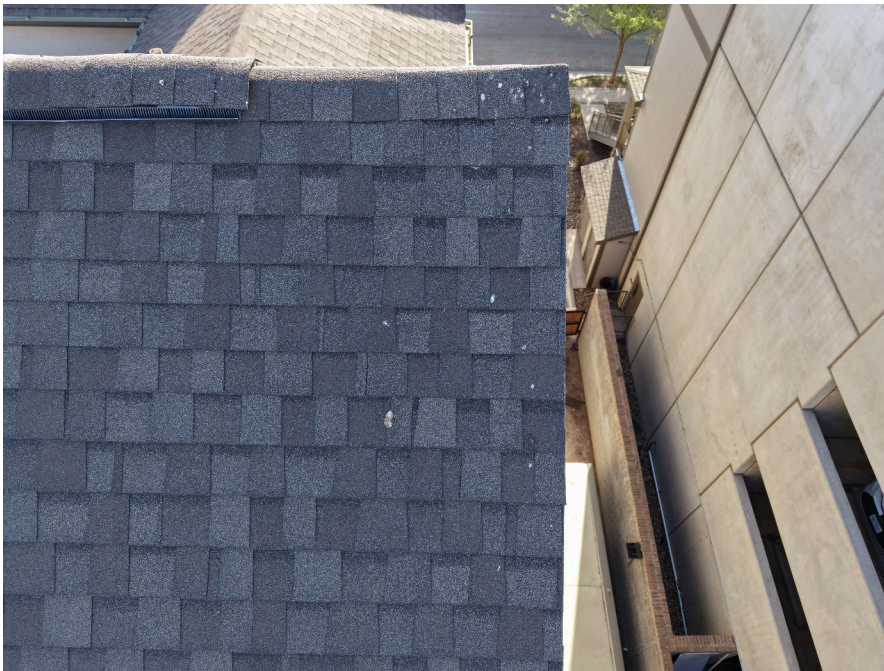
Wind Damage (85%)

Location: Far left side of the ridge cap

A single ridge cap shingle on the far left is slightly lifted at its corner. This appears to be an isolated incident.

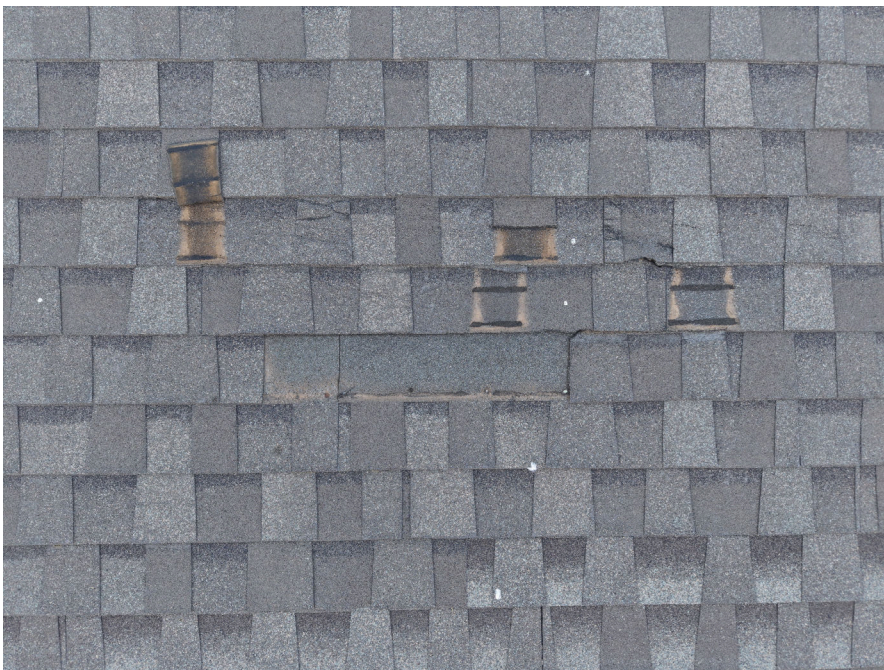
Shingle Damage (100%)

Location: Center of the image, spanning across multiple courses.

Multiple architectural shingles show severe delamination of the top layer, resulting in large, rectangular patches of complete granule loss exposing the underlying fiberglass mat. This represents a complete failure of the affected shingle tabs.

Wind Damage (95%)

Location: Upper left quadrant of the image.

A single shingle tab is lifted, creased, and folded upwards, indicating it has been caught and damaged by wind. This creates a high-risk entry point for water.

Cracked Shingles (100%)

Location: Central area of the image, adjacent to the main damage.

At least two shingles exhibit significant stress cracks. One horizontal crack runs along the top of a shingle, and another crack is visible on a shingle to the right of the delaminated area. These cracks compromise the shingle's water-shedding ability.

Exposed Nails (85%)

Location: Scattered within the central damaged area.

Multiple bright white spots consistent with sealant applied over exposed nail heads are visible. While sealed, they represent potential future leak points if the sealant deteriorates.

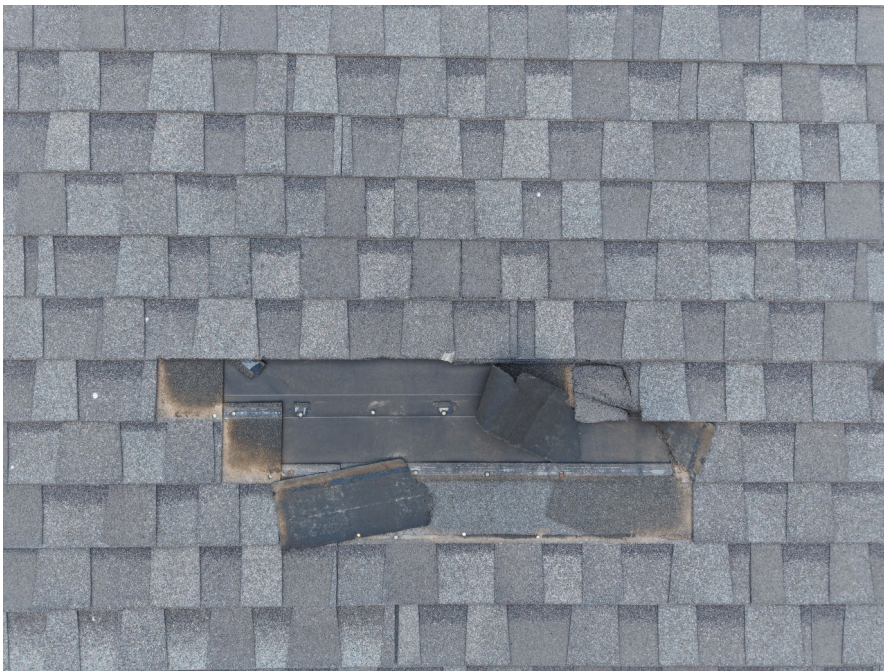
Wind Damage (100%)

Location: Center of the image

A large rectangular section of shingles is missing and torn, exposing the underlying vent structure. Shingles are ripped, broken, and completely removed from this area, indicating significant force.

Missing Shingles (100%)

Location: Center of the image, surrounding a vent.

Multiple architectural shingles are completely missing or have large sections torn off in a concentrated area, exposing the roof deck or a vent system underneath. The damaged area spans the width of several shingle tabs.

Exposed Nails (100%)

Location: Within the large damaged area in the center of the image.

Numerous fasteners (nails) are visible and exposed to the elements where the shingles have been torn away. This creates direct paths for water intrusion.

Hail Damage (90%)

Location: Scattered on shingles surrounding the main damaged area.

Several small, circular spots of granule loss are visible on intact shingles. These impacts appear as lighter-colored circles, consistent with hail strikes.

Cracked Shingles (95%)

Location: On a shingle to the left of the main damaged area.

At least one shingle shows a vertical crack running through the tab, which could be from stress, age, or impact.

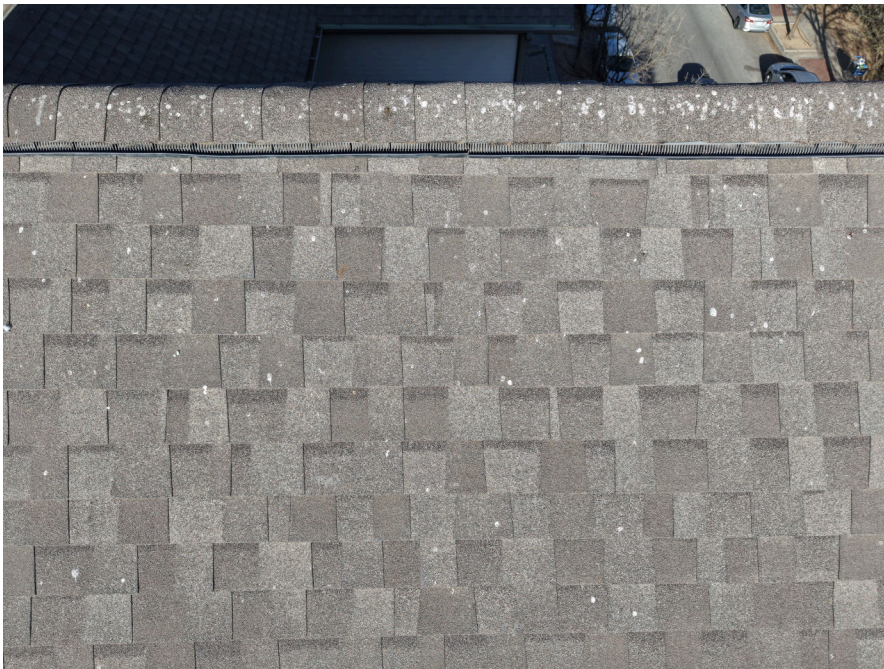
Hail Damage (90%)

Location: Scattered across the entire visible roof slope and ridge cap.

Numerous small, circular impact marks are visible across the field shingles and ridge cap. These impacts have caused granule loss, exposing the lighter-colored shingle substrate underneath. The pattern is random and consistent with hail strikes.

Algae Moss (85%)

Location: Primarily concentrated on the ridge cap shingles, with some spots on the main slope.

White and light gray splotches, consistent with bird droppings or lichen, are present on the roof surface. The heaviest concentration is along the ridge.

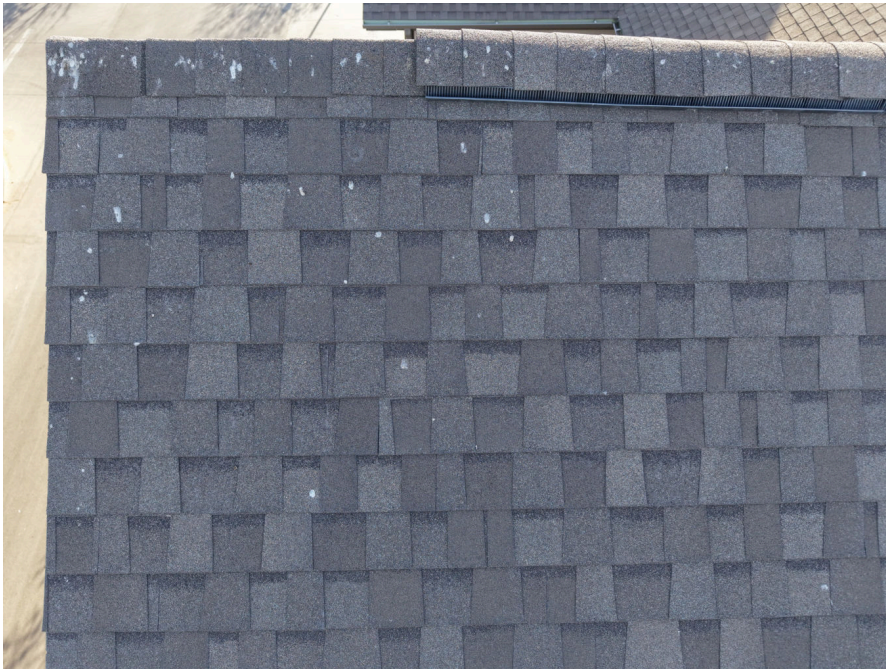
Hail Damage (95%)

Location: Scattered across the entire visible roof slope.

Multiple small, circular impact marks are visible across the roof plane. These marks are characterized by granule loss, exposing the darker asphalt mat underneath. The impacts are randomly distributed, which is a classic pattern for hail damage. Several distinct impacts are visible in the upper and central portions of the image.

Mechanical Damage (80%)

Location: Along the ridge cap at the top left and scattered in various spots.

Several white splotches are present on the shingles, most concentrated on the ridge shingles at the top left. These appear to be a foreign substance like paint splatter or bird droppings, not a defect of the shingle itself.

Granule Loss (90%)

Location: Scattered across the roof, associated with hail impacts and general wear.

There is noticeable granule loss in small, circular patterns consistent with hail strikes. Beyond the specific impact points, there is minor, generalized granule loss typical of an aging roof, but the hail impacts are the primary concern.

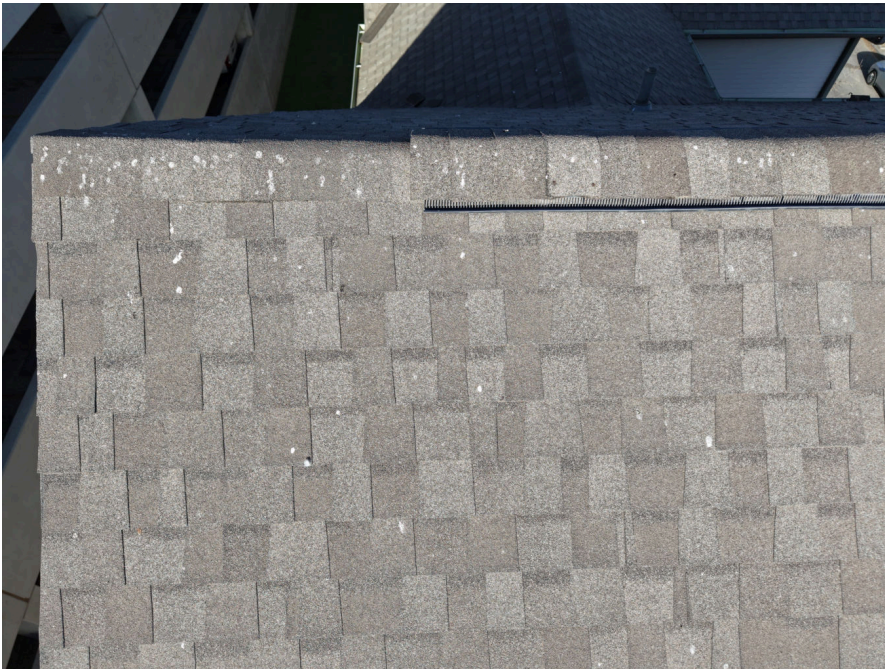
Hail Damage (85%)

Location: Scattered across the main roof slope shown in the image.

Multiple small, circular dark spots are visible on various shingles. These spots are consistent with hail impacts that have caused granule loss, exposing the underlying asphalt mat. At least 5-10 distinct impacts can be identified.

Granule Loss (90%)

Location: Widespread across the entire visible roof surface.

General, age-related granule loss is evident, creating a mottled or slightly varied color pattern on the shingles. This is typical wear but reduces the shingles' protective capability over time.

Exposed Nails (95%)

Location: On a shingle course just below the ridge, to the left of the ridge vent.

At least two nail heads are visible on the surface of a shingle near the ridge. They appear raised and unsealed, creating potential entry points for water.

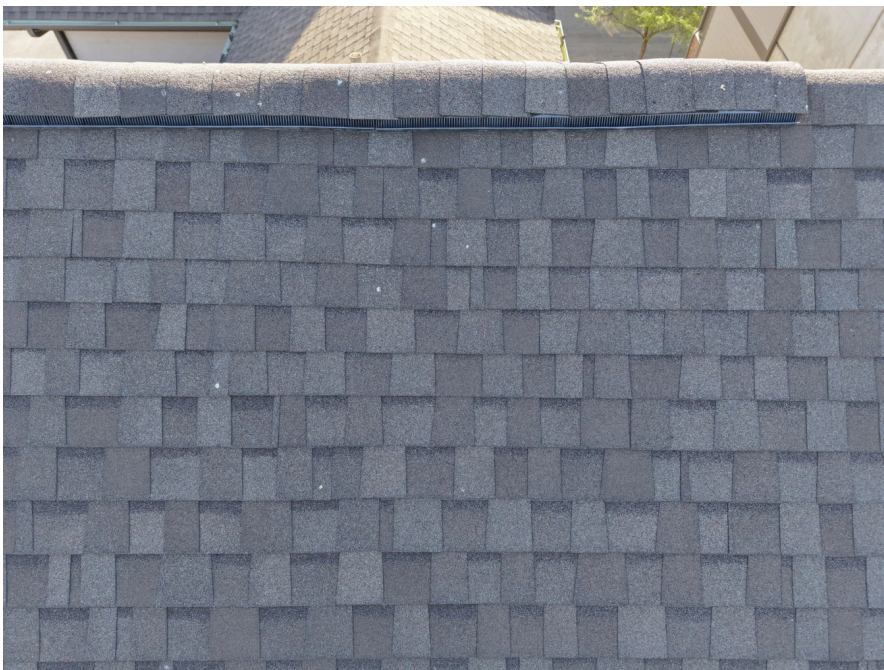
Hail Damage (90%)

Location: Scattered across the entire visible roof slope and on the ridge cap shingles.

Multiple small, circular impact marks are visible on the shingles, consistent with hail strikes. These impacts have caused localized granule loss, exposing the lighter-colored shingle mat underneath. At least 10-15 distinct impacts can be seen in the provided images.

Exposed Nails (85%)

Location: Randomly scattered on the field shingles.

Several bright white spots are visible, consistent with exposed or poorly sealed nail heads. These represent potential water intrusion points. Approximately 4-5 are visible in the main image.

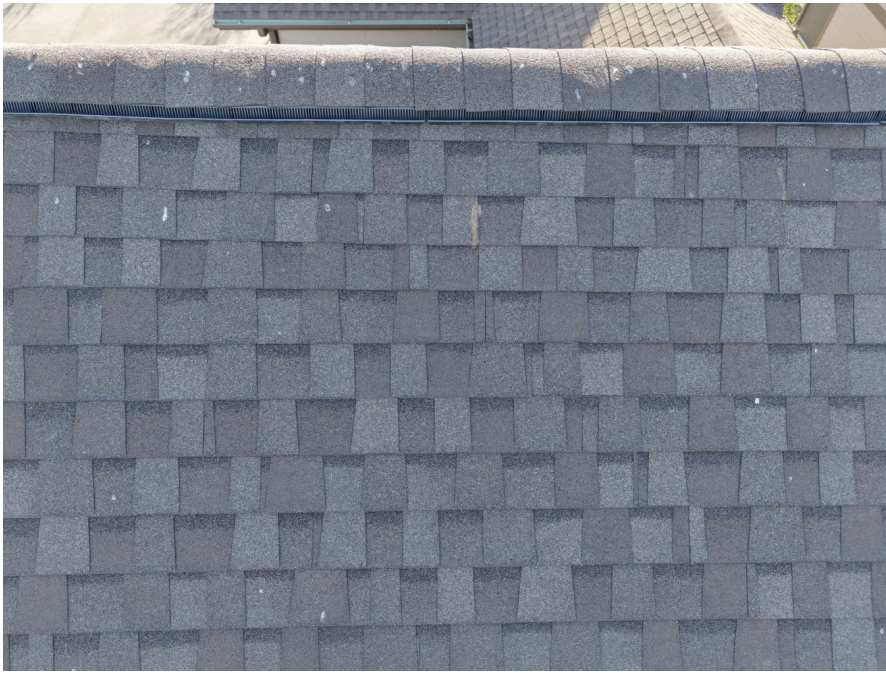
Hail Damage (95%)

Location: Scattered across the roof slope, including on the ridge cap shingles and upper rows of field shingles.

Multiple (10+) distinct, circular impact marks are visible where granules have been knocked off, exposing the lighter-colored shingle substrate. These impacts are randomly scattered, a classic sign of hail strikes.

Mechanical Damage (80%)

Location: Upper left-center of the visible roof slope.

A single, vertical, light-colored scuff mark or sealant smear is present on one shingle tab. This appears to be an isolated cosmetic issue, possibly from foot traffic or a tool.

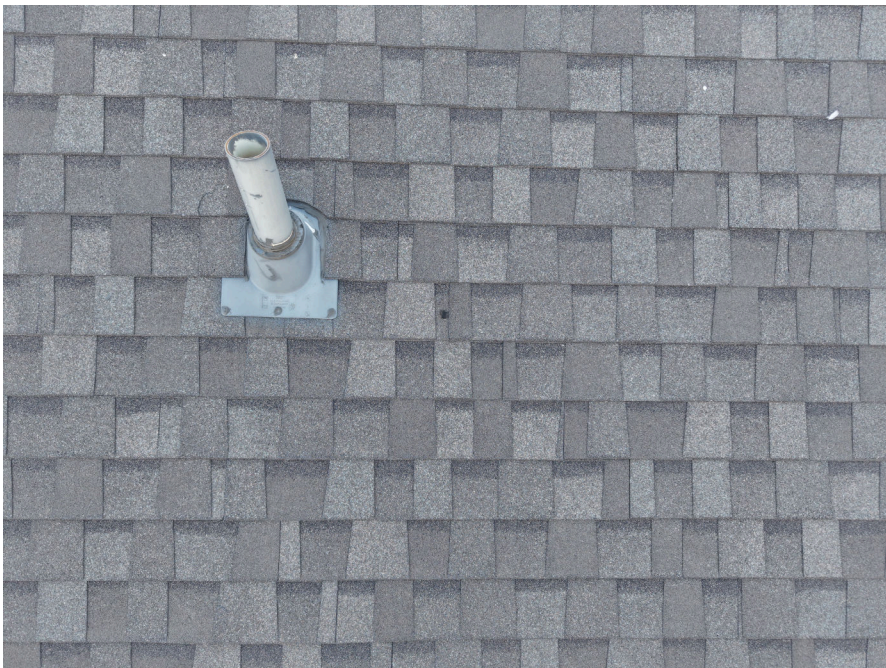
Hail Damage (95%)

Location: Scattered across the visible roof slope, with a very clear impact mark on the shingle immediately to the right of the vent pipe base.

Multiple small, circular impact marks are visible on the architectural shingles. These marks appear as dark divots where granules have been forcefully removed, exposing the underlying asphalt mat. The pattern is consistent with hail.

Pipe Boot Failure (80%)

Location: At the base of the white vent pipe where it exits the metal boot flashing.

The sealant around the pipe appears thick, lumpy, and is showing signs of cracking and potential separation. This compromised seal is a significant risk for water intrusion.

Cracked Shingles (70%)

Location: Isolated shingles, with one noticeable crack on a shingle to the right of the vent pipe.

A few shingles show minor, fine linear cracks. This appears to be age-related stress, potentially exacerbated by hail impacts.
